2010 / 11 year end report:
Plantation Report for Kangaroo Island, S.A.

Viento Forestry Pty Ltd

August, 2011.

Sylva Systems Pty. Ltd.

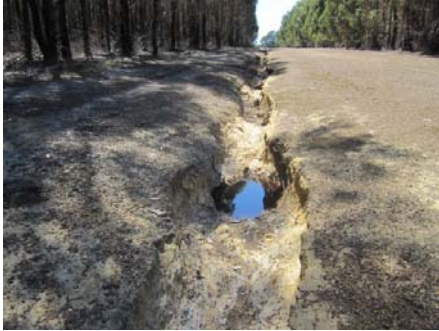
The tracks are generally in good order, however, some creek and drainage line crossings require attention for improved access, with particular attention required to the east – west road through the property. Photographs 1 to 3 indicate the main issues to be addressed.

Photograph 1: A section of deep scouring of the main east-west road in Stun Sail Boom.

Recommendation *At least one culvert pipe is required to be installed to drain across the road under the road surface. This is an issue that should be addressed prior to the coming fire season.*

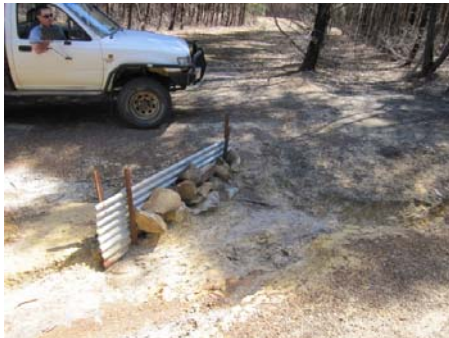
Photograph 2: A section of the main east-west road in Stun Sail Boom presenting a structure to divert the water across the road surface.

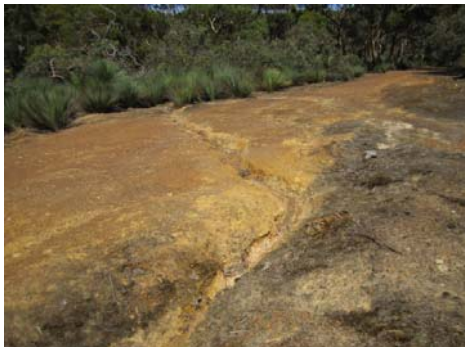
Photograph 3: A section of the main east-west road in Stun Sail Boom presenting an eroded cross drain for the water across the road surface. The defect in the road surface is such that a fire tanker would be unable to use the road.
